LPBF
SAVE OUR LAKE
SAVE OUR COAST

Coastal Sustainability Program

Mardi Gras Pass

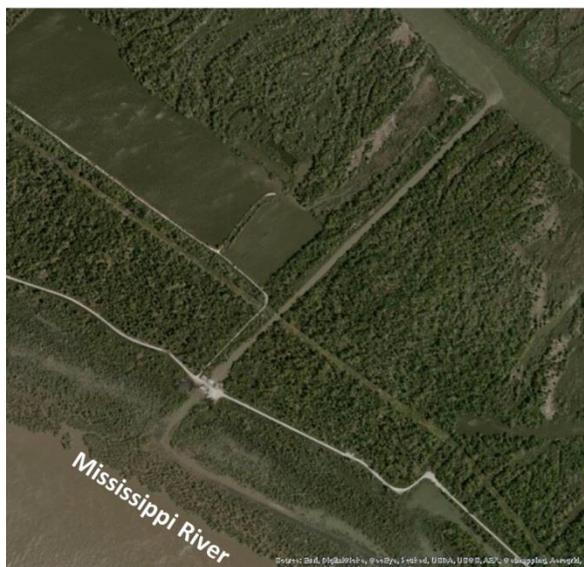
Pre- Mardi Gras Pass in 2010

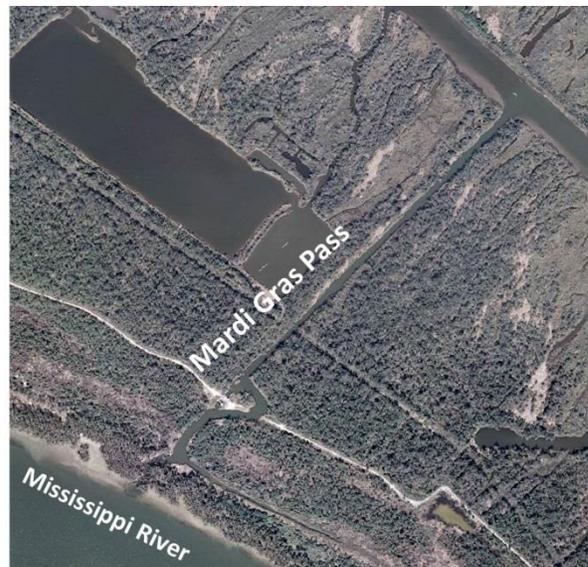
Mardi Gras Pass in 2012

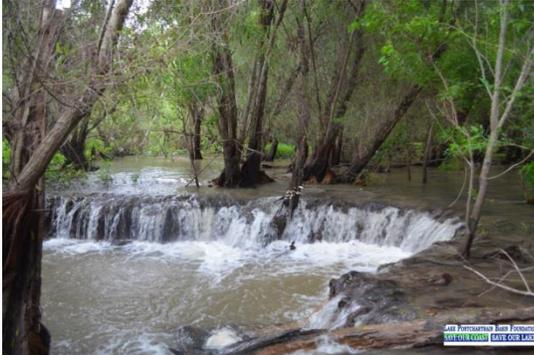
- Mardi Gras Pass developed through a process of headward erosion, eroding from the marsh side toward the Mississippi River during high water

Headward erosion at Mardi Gras Pass

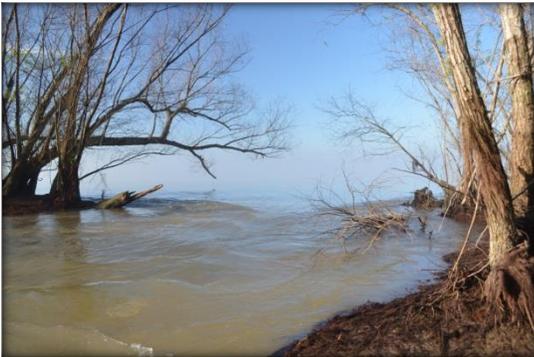
- Mardi Gras Pass breached to the river in March 2012

Mardi Gras Pass flowing to the Mississippi River, March 14, 2012

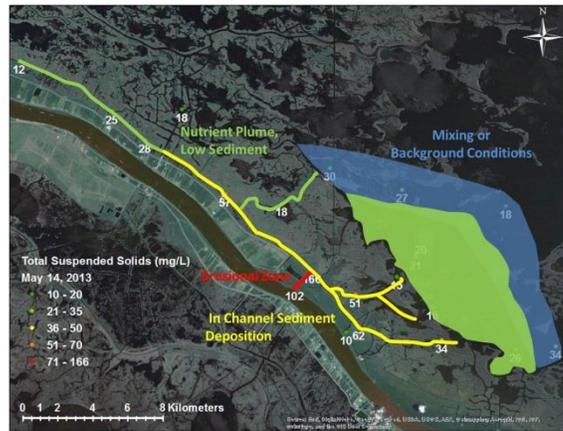
- Sediment and nutrient distribution from the pass lead to four zones; erosion, sediment deposition, nutrient plume and mixing

Four zones created by Mardi Gras Pass discharge. Sediment deposition is mostly in channel and does not reach the bay
