Measurements of lateral flow from the Mississippi River using a towed trimaran near the Bohemia Spillway

A field report

Coastal and Environmental Hydrodynamics Laboratory

University of New Orleans

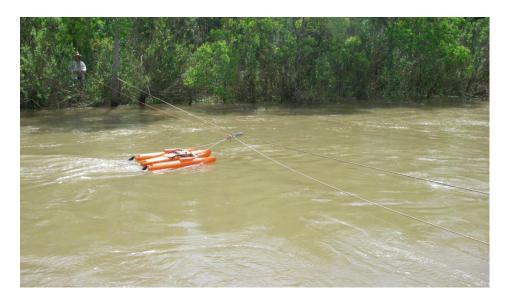
Figure 1. Trimaran transversing the cut

To measure flow, we used an Acoustic Doppler Current Profiler (ADCP), and used the instruments bottom track for positioning. The survey was conducted in an area where turbulence and air bubbles were at a minimum, to avoid acoustic errors and therefore errors in the flow measurement. We used a trimaran, towed along the width of the channel using a rope. The instrument is employed with a Bluetooth connection, and transmits data to the bank, where a computer receives the data instantaneously. Several passes were conducted to ensure consistency.

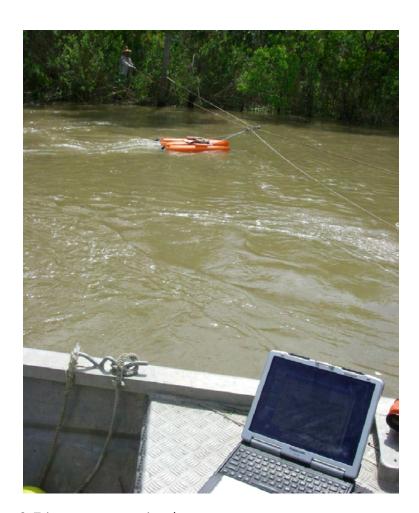
Figure 2. Trimaran transversing the cut
